NUMBER 053

MODEL Spectra

### TECHNICAL SERVICE BULLETIN

SAFETY CAMPAIGN: 2004-2005 SPECTRA PASSENGER SEAT OCS REFLASH

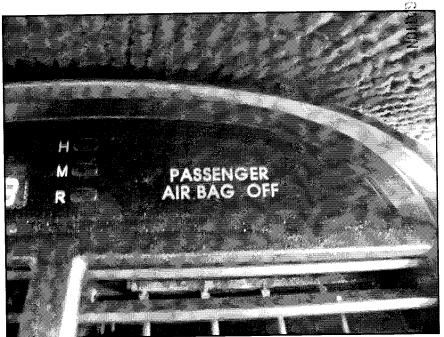
This bulletin provides information relating to possible improper OCS classification of a child restraint seat. On some 2004 and 2005 Spectra models produced between 12/11/03 and 4/18/05, the tell tale lamp on the center facia panel may turn off (PASSENGER AIR BAG ENABLED) when the passenger seat is occupied by a child restraint seat.

Passenger Air Bag Tell Tale Lamp

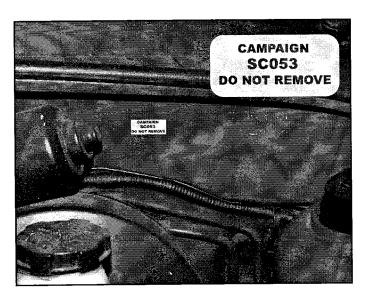
- 1. Open hood and check for SC053 Campaign Completion Label on the bulkhead above the brake booster.
  - If label exists, Campaign SC053 has been completed - NO FURTHER ACTION IS REQUIRED.
  - If Campaign SC053 label DOES NOT EXIST, perform the Reflash Procedure.

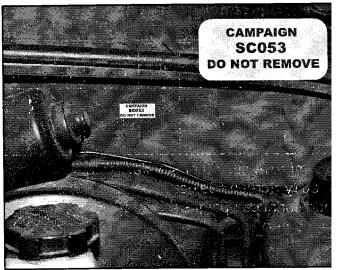
- 6. After completion of reprogramming, turn the ignition key to the off position, disconnect the OC Reprogramming Tool electrical connection at the power supply and OCS seat connector. Connect the OCS wire harness to the OCS connector under the right front passenger seat.
- 7. Perform a functional check of the OCS system:
  - a. Turn the ignition switch off for 5 seconds.
  - b. Turn the ignition switch ON, monitor the tell-tale lamp on the center facia panel. The "PASSENGER AIR BAG OFF" should light up initially, and then turn OFF and back ON.
  - c. Sit in the front passenger seat. If you weigh at least 105 lbs, the light should then go OFF.
  - d. Verify that the airbag/SRS warning lamp is off after initial bulb check.
- 8. Attach the SC053 Campaign Completion Label on the on the bulkhead above the brake booster.
